OVERVIEW: Chickamauga Greenway Slope Stabilization - Chattanooga, Tennessee

PRODUCT:	ArmorFlex Class 30s and 45s Articulating Concrete Block Mats
AMOUNT:	5,184 Square Feet
DATE:	Fall 1998
OWNER:	City of Chattanooga, TN
ENGINEER:	City of Chattanooga: J.D. Wilkinson, Jr., P.E.
CONTRACTOR:	City of Chattanooga
SUBMITTED BY:	David Kees
DATE:	March 2004

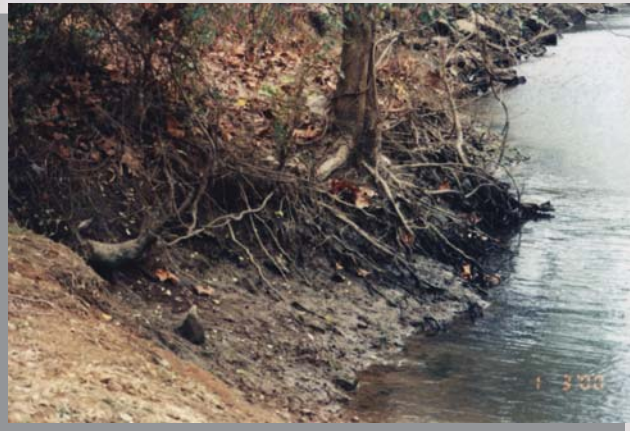
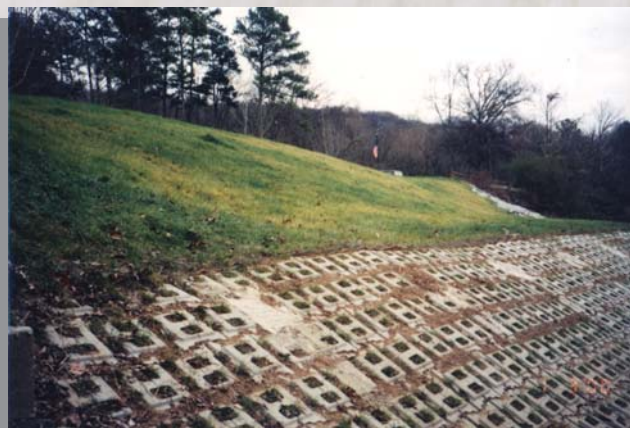
Considering the original slope prior to site preparation was 1:1 and consisted of many potential failure plains, the project engineer decided to design an embankment consisting of three unified slopes. The lower, or base, slope was cut at 2:1 from below the waterline to the anchor trench, which rose to six feet (1.82 meters) above the lowest known water level. This slope was then smoothed and top-dressed with 1/2-inch (#57 Limestone rock) drainage stone. A middle or bench, slope was cut just above it to 10:1. Finally, the upper slope was cut to 2:1, which rose to the parking lot. The top two slopes were protected with turf reinforcement matting.

The City Engineer and TVA decided to use ArmorFlex *Articulated Concrete Block* mattress system to protect the subgrade against high velocity water flows. With 5,184 square feet of ACBs installed, the bank would receive the stability it needed. Open-cell block was selected for the slope to allow vegetation to grow to the waterline and provide the release of hydrostatic pressure from within the embankment.
